## **Geologic Controls of Sand Boil Formation at Buck Chute, Mississippi**

June 2017

Final report

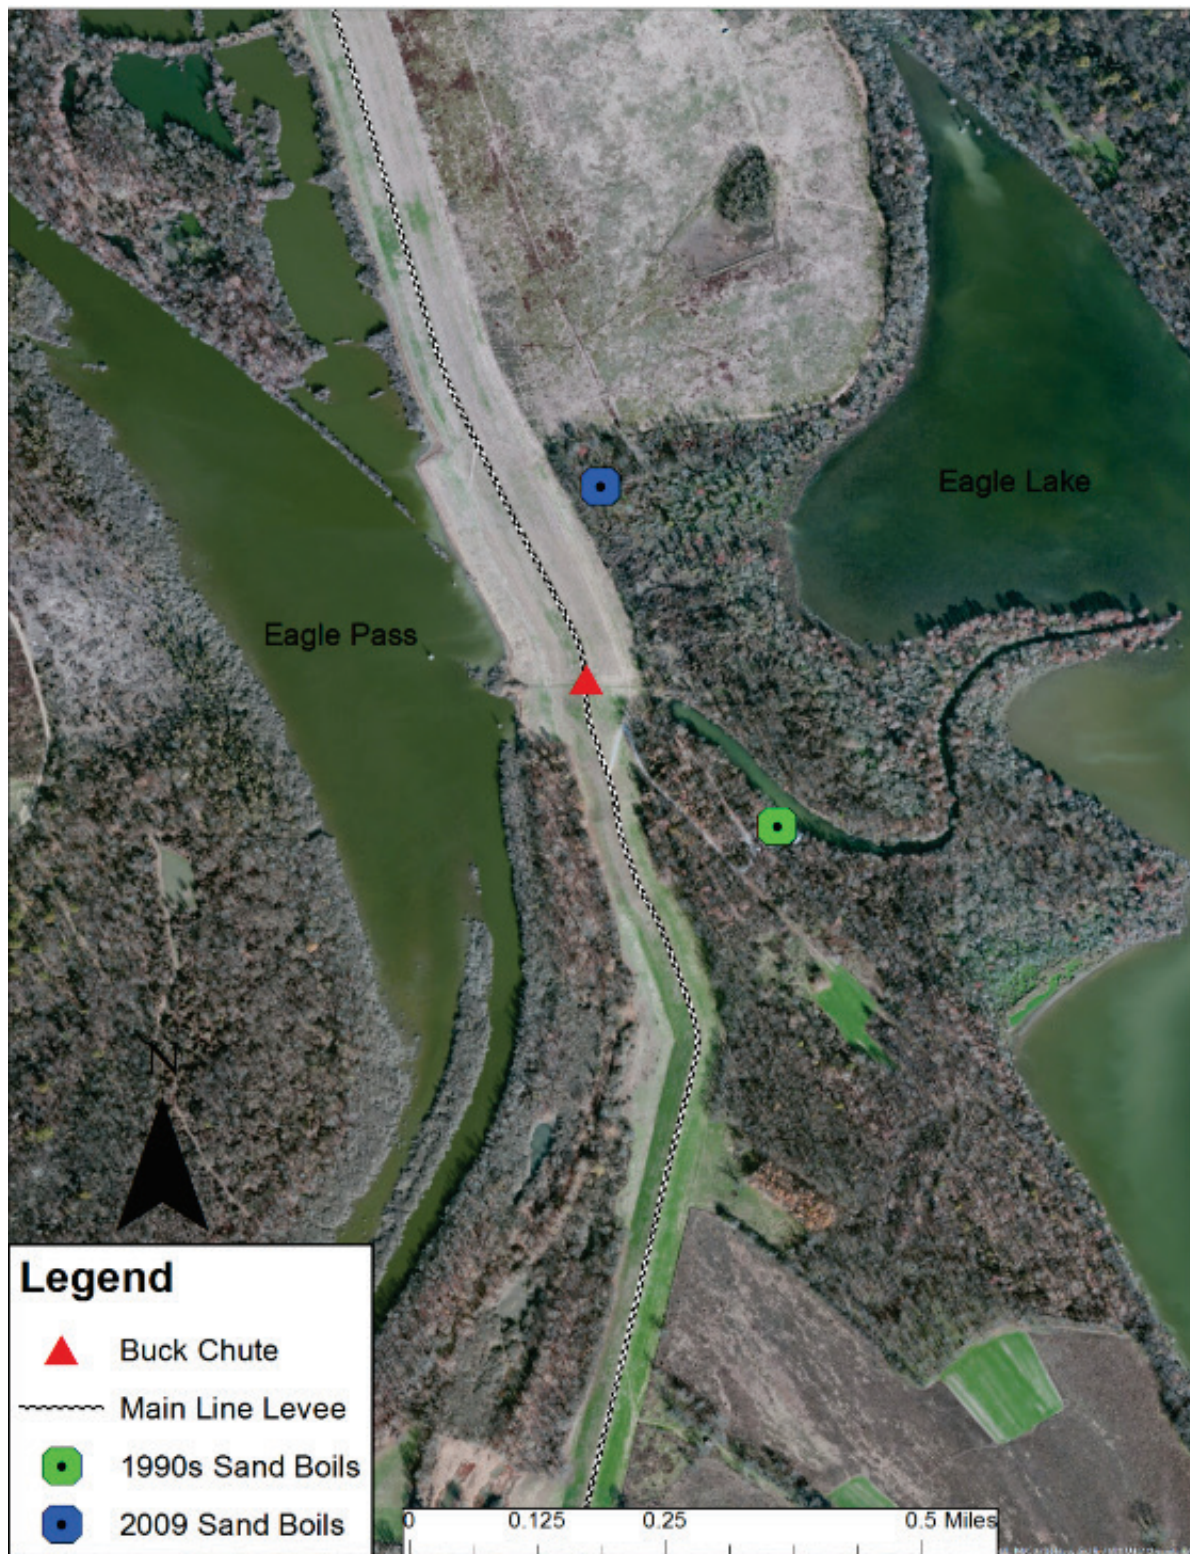
Figure 3. Aerial imagery of the immediate vicinity of the Buck Chute site with the locations of sand boils (Modified from World Imagery base map downloaded from ESRI ArcMap 10.1 library).

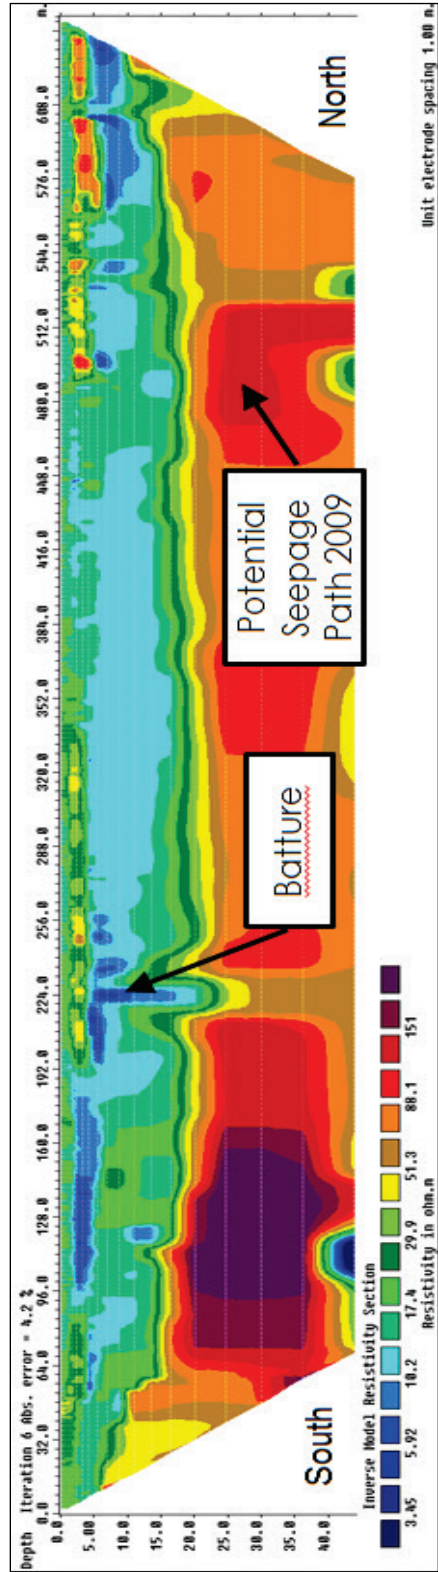
Figure 15. ERT results near the 2009 sand boils from January and February.

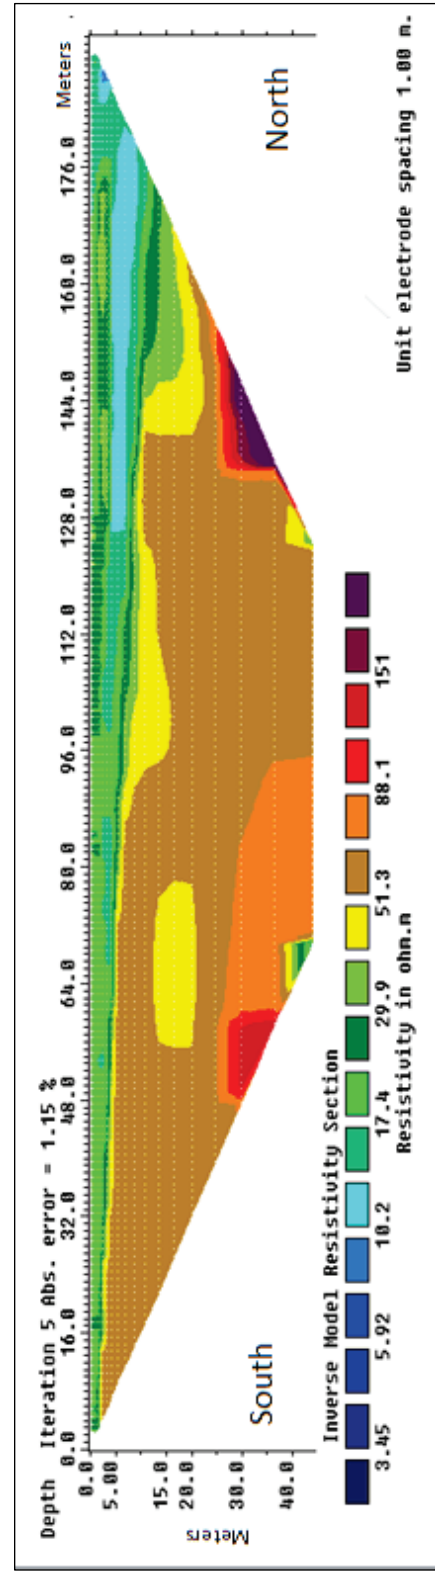
The 7 March 2014 survey was performed to identify possible seepage pathways for the 1990s sand boil occurrences; however, the survey could not be extended far enough south because surface conditions prevented emplacement of electrodes. Due to the orientation of the path through the woods in the southern portion of the study area, the survey was not able to be combined with the 15 January through 19 February surveys. The results are interpreted as a blanket, which thins rapidly from the north to the south (Figure 16).

Figure 16. ERT results near 1990s sand boils from March 2014.

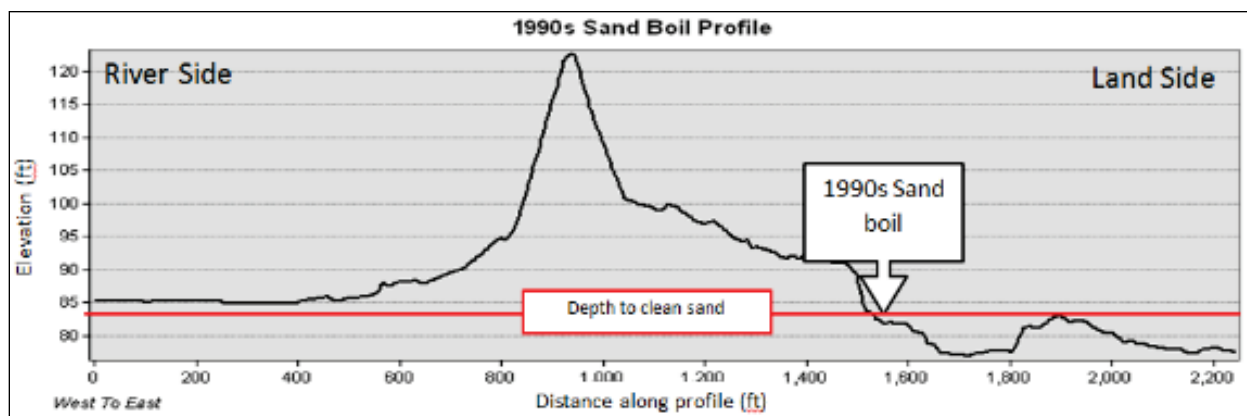
Figure 25. 1990s sand boils elevation profile.

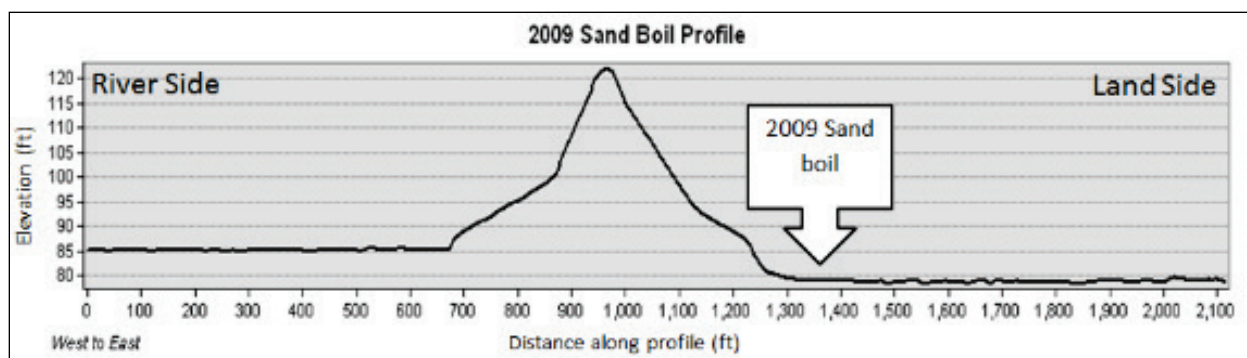
Figure 26. 2009 sand boils elevation profile.

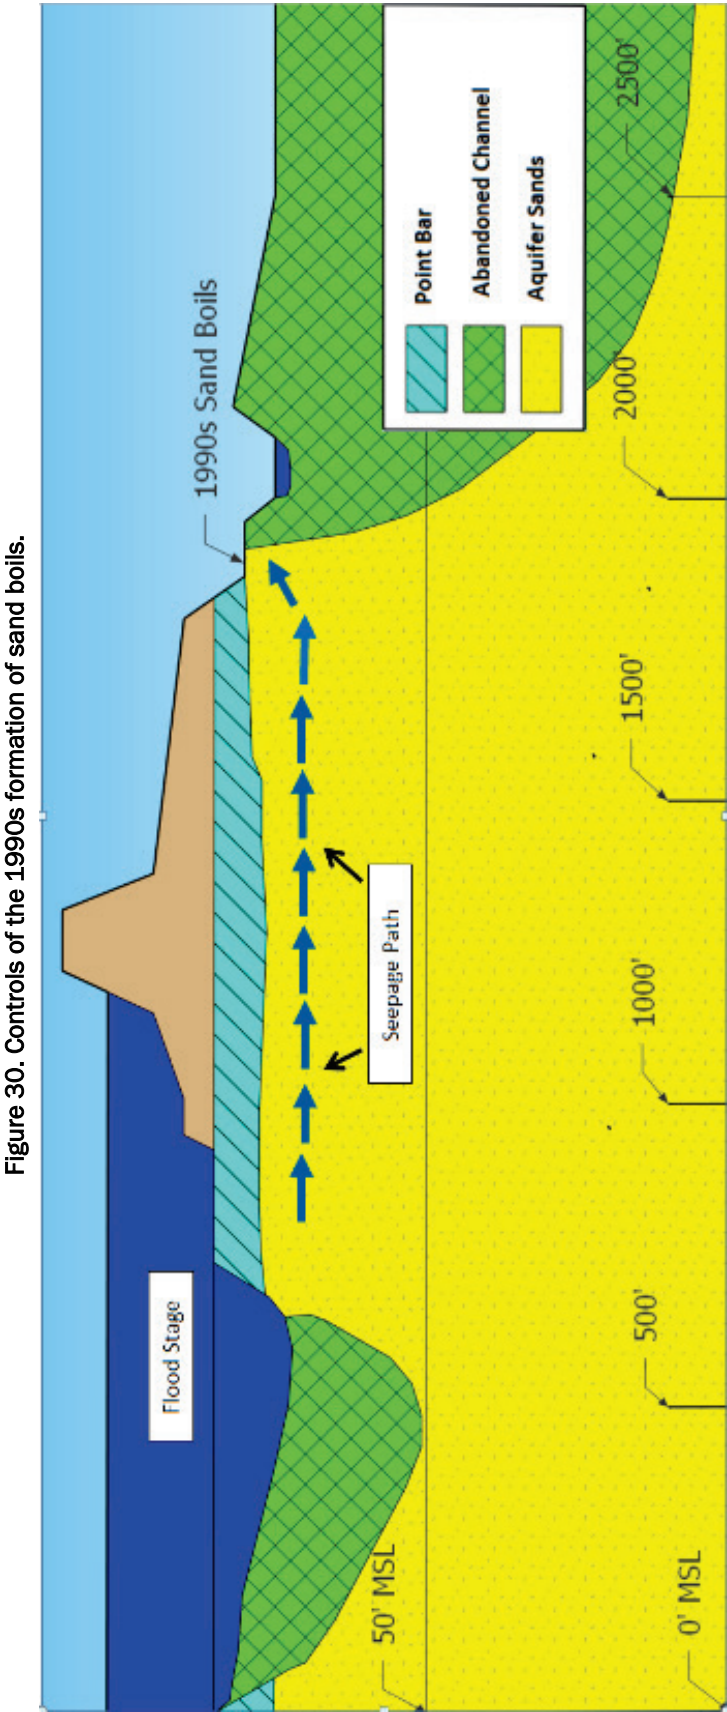
present. The ERT data provided a continuous cross section that shows more resistive material, which coincides with more sandy, unsaturated material near the surface with a very thin silt blanket. Figure 30 is the interpretation of the geologic controls of the 1990s boils derived from data collected and interpretation of literature review. The blanket is non-existent at the location of the boils on the landside; the topographic low where the boils were located is into the sands of the alluvial aquifer. To cause heave and subsequent boil formation at this location, little increase in subsurface hydrostatic pressure is required due to lack of blanket overburden.

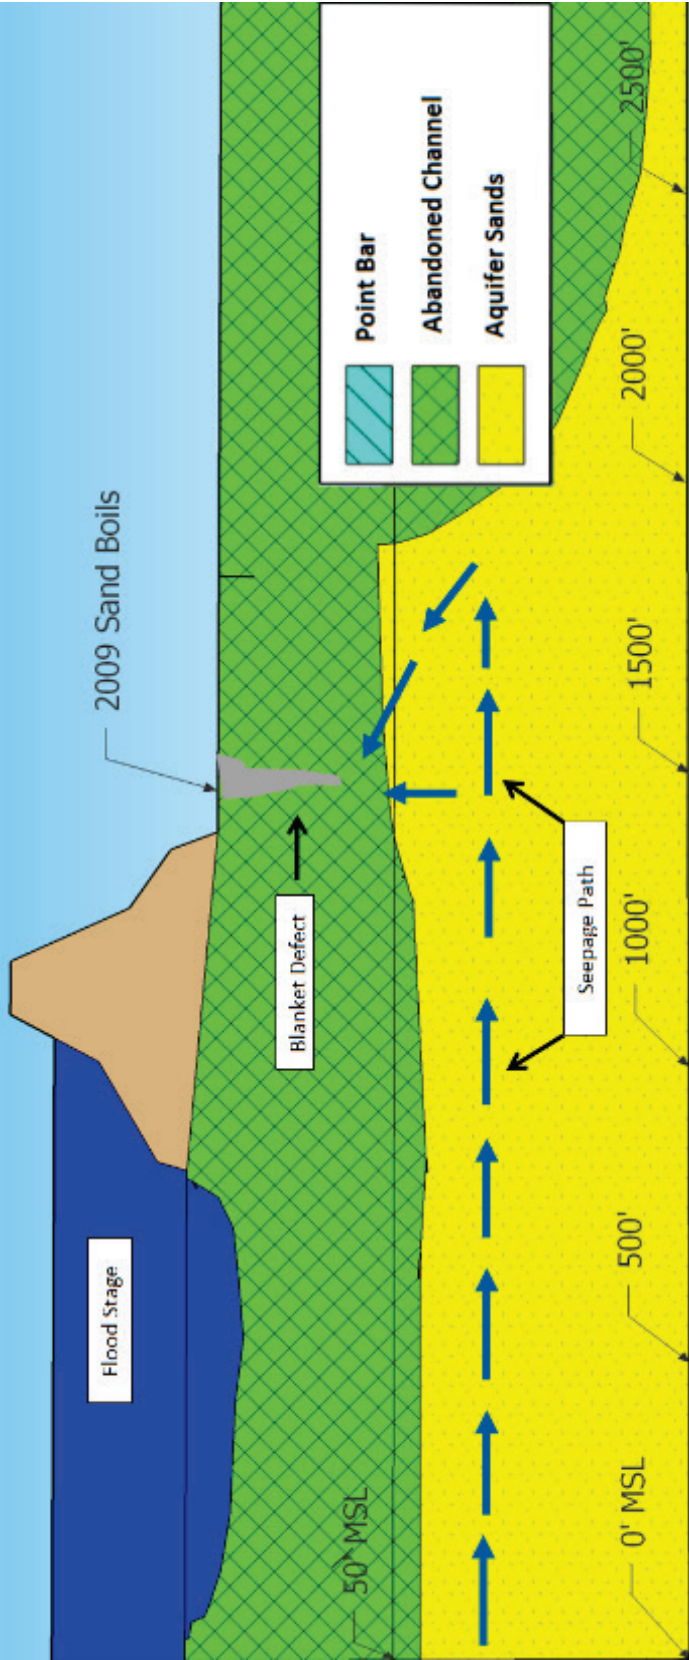
At the 2009 sand boil location, abandoned channel deposits are shown on the geologic map at this site. Abandoned channel deposits mostly consist of clays with some silty sands, and these deposits extend to a depth of 60 to 70 ft. The CPT data for this location show the top stratum to be lenses of silts and organics with a thickness of 20 to 30 ft. The control of the 2009 sand boil formation is a blocked seepage path. The abandoned channel deposit in the lacustrine stage (Eagle Lake) acted as a clay plug blocking the subsurface flow and creating localized increase in hydrostatic pressure (Figure 31). The increased pressure, coupled with a likely defect in the blanket, fallen tree, or inconsistency in the blanket, created the heave conditions that led to the sand boil formation.

Figure 31. Controls of the 2009 formation of sand boils.

The boil activity from 2009 is attributed to blocked seepage pathways. The blanket near the boil location does show a somewhat uniform thickness but not necessarily uniform composition. The proximity of the abandoned channel deposit that is now Eagle Lake reduces the subsurface flow from the riverside landward. This reduction increases the hydrostatic pressure behind the clay plug of the abandoned channel deposit, straining any imperfections present in the blanket causing heave. Possible imperfections of the blanket are as complex as the inconsistencies shown in CPT data or as simple as a hole left by a fallen tree's root ball.
